Capitol Hill Home Inspection, LLC

Confidential - Property Inspection Report - Confidential

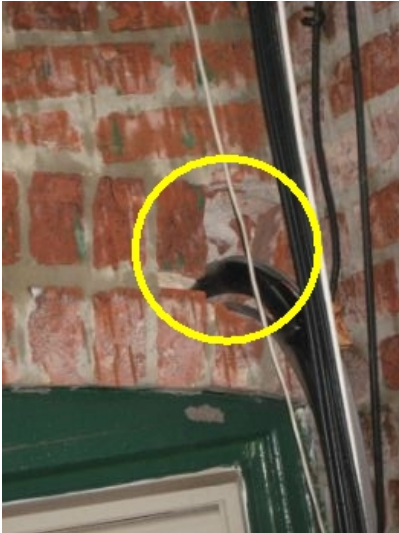
Several gaps present at exterior vent/duct penetrations

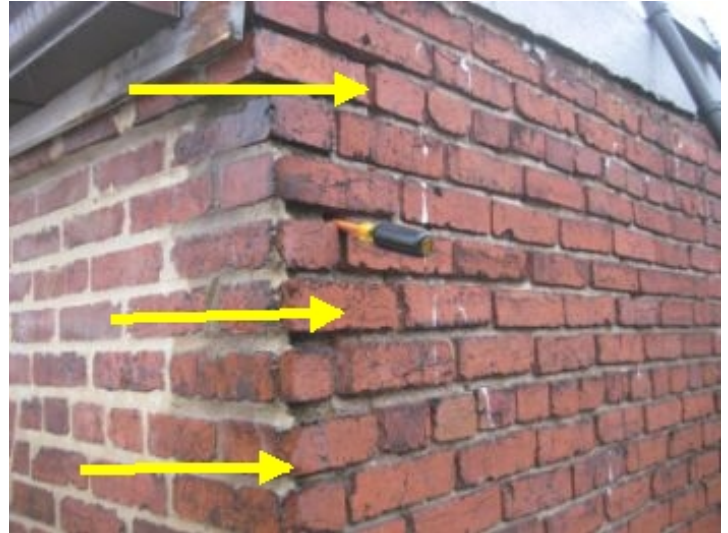
Cracks & openings in mortar joints at 3rd floor exterior wall were deteriorated

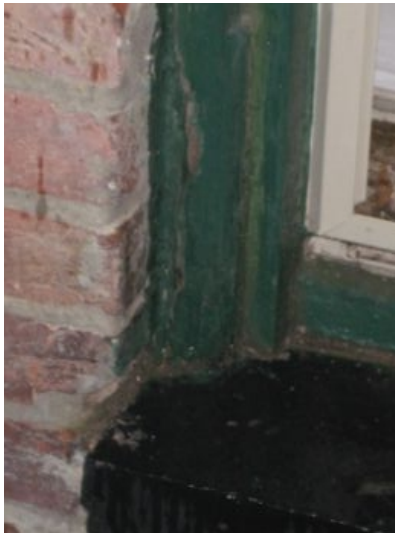
Several rear windows have deteriorated trim and are not sealed against the brick

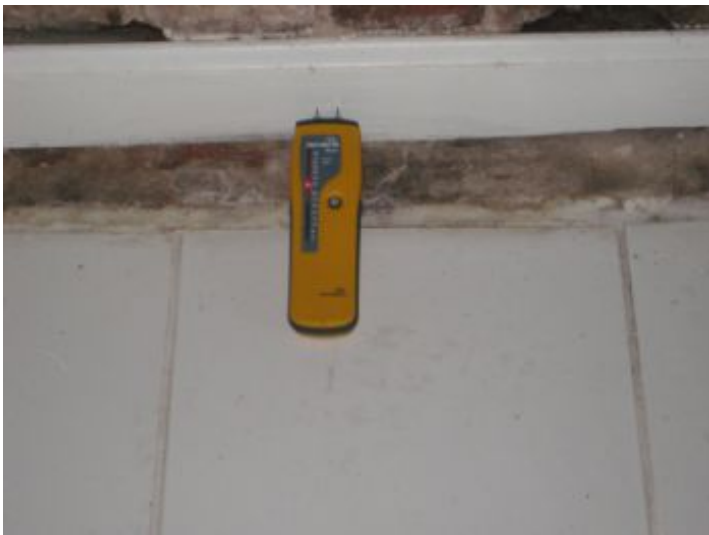
Basement baseboards had an elevated level of moisture present

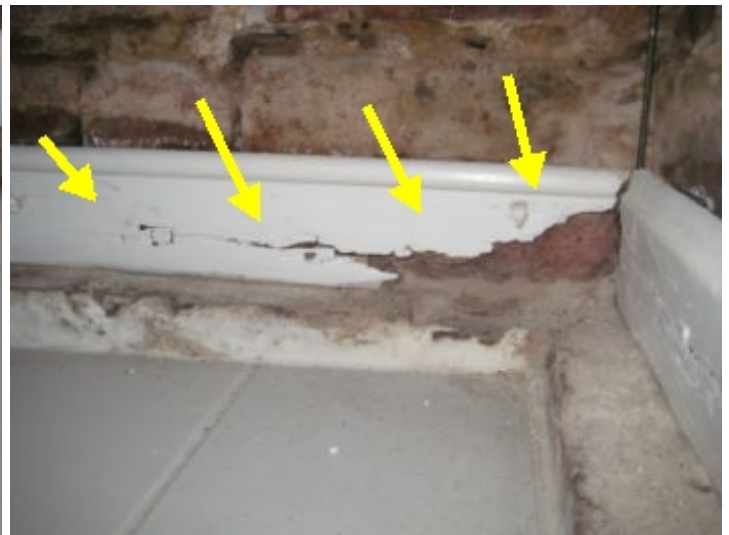
Baseboard at basement floors were substantially deteriorated - possible termite presence

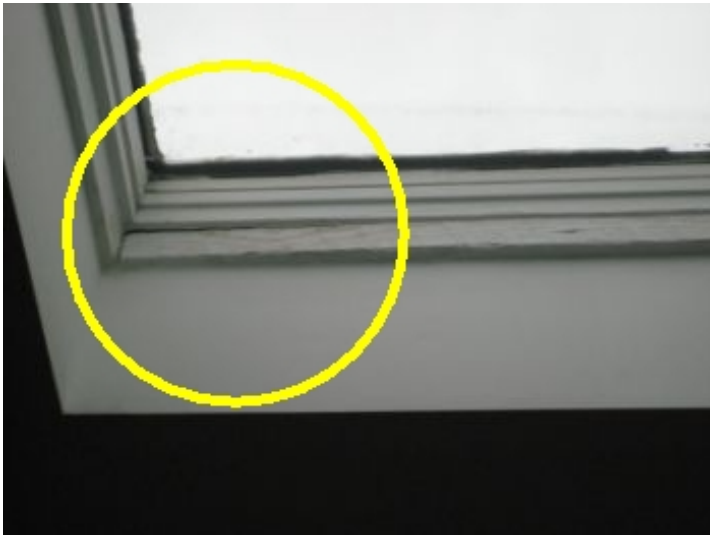
Ceiling around 3rd floor skylight appeared to be damaged from a possible leak

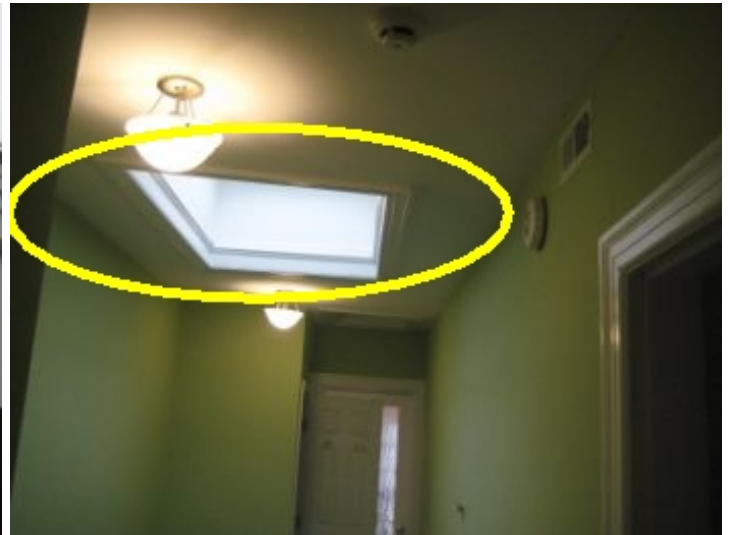
Ceiling around 3rd floor skylight appeared to be damaged from a possible leak

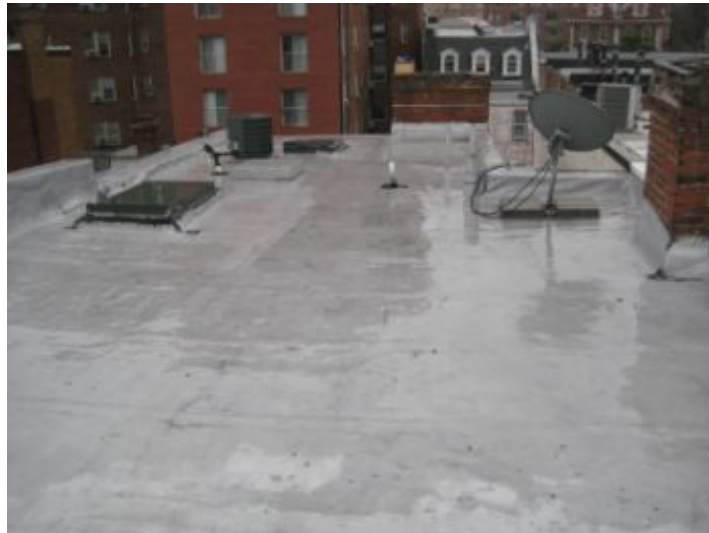
Modified bitumen roof was deteriorated with substantial cracking at the surface

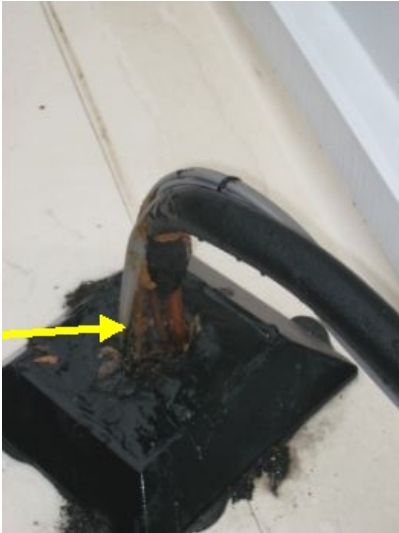
Refrigerant lines at EPDM roof were sealed with expanding foam which was deteriorated at the time of the inspection

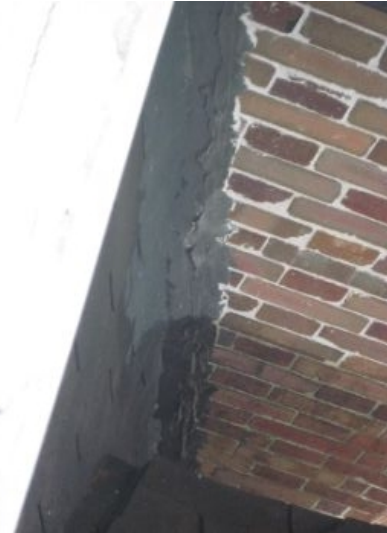
Step flashing at front front was not functional and cover with asphalt based sealant without UV protection

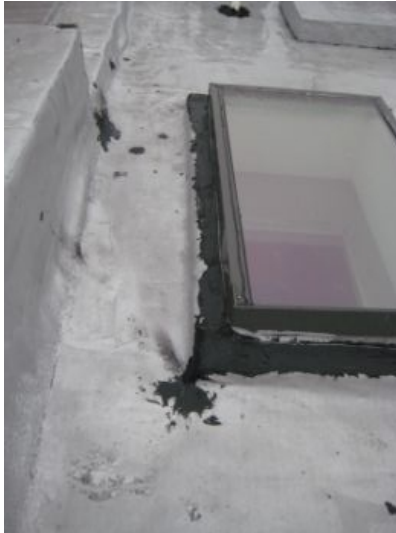
Flashing around sky lights was deteriorated and improperly repaired

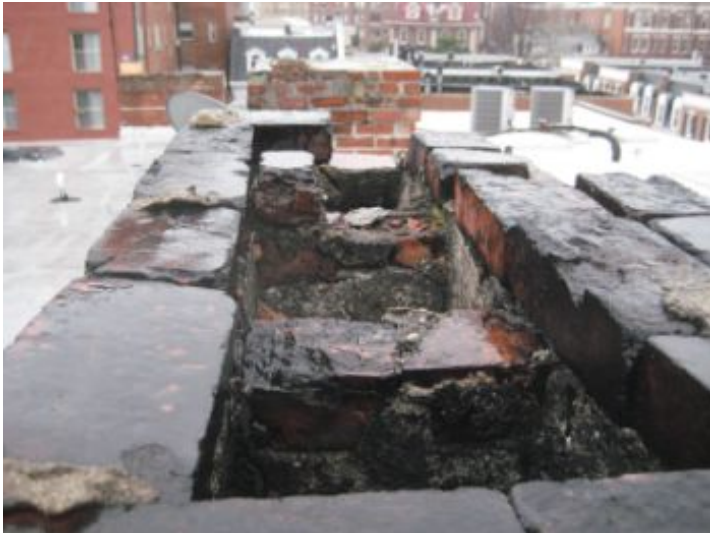
Bricks and mortar were substantially deteriorated at all 3 chimneys

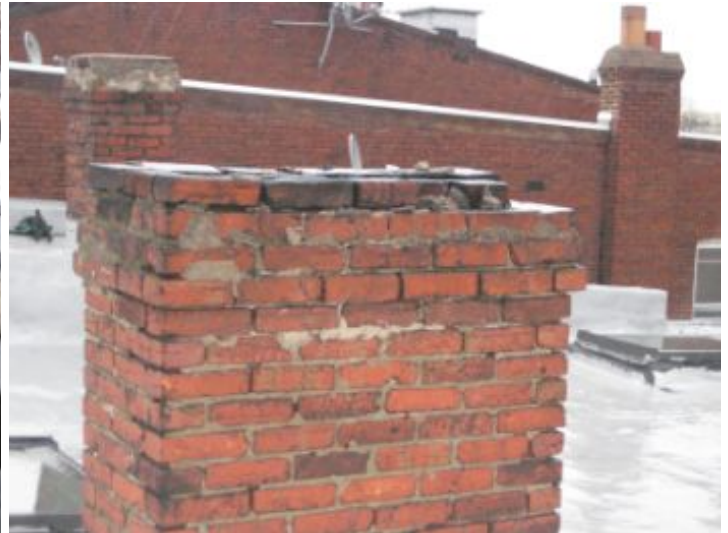
Recommend consulting with a licensed chimney contractor to determine scope of work to repair chimneys & fireplaces

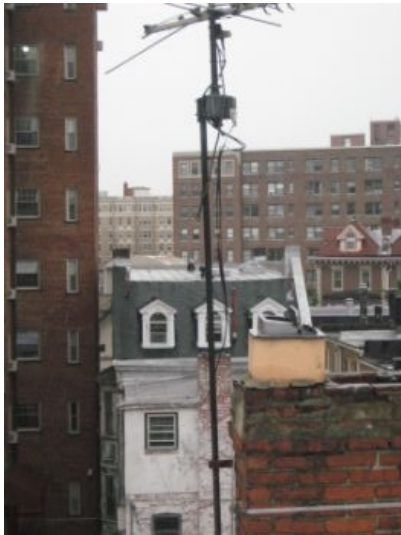
Large TV antennae attached to chimney

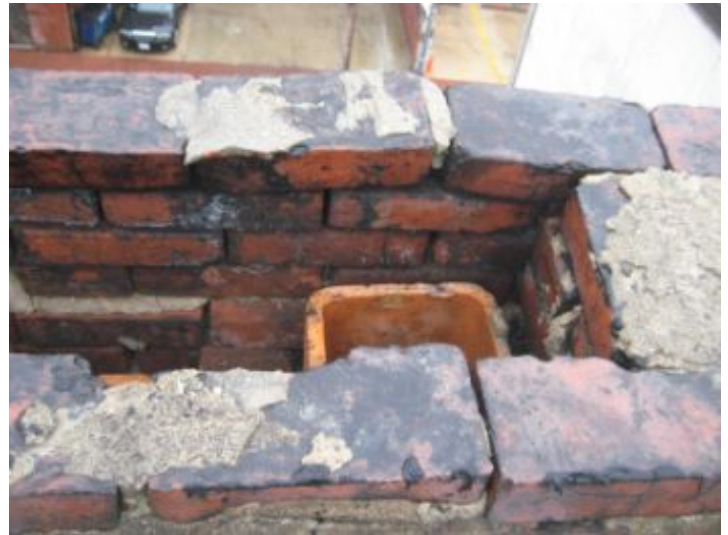
Bricks and mortar were substantially deteriorated at all 3 chimneys

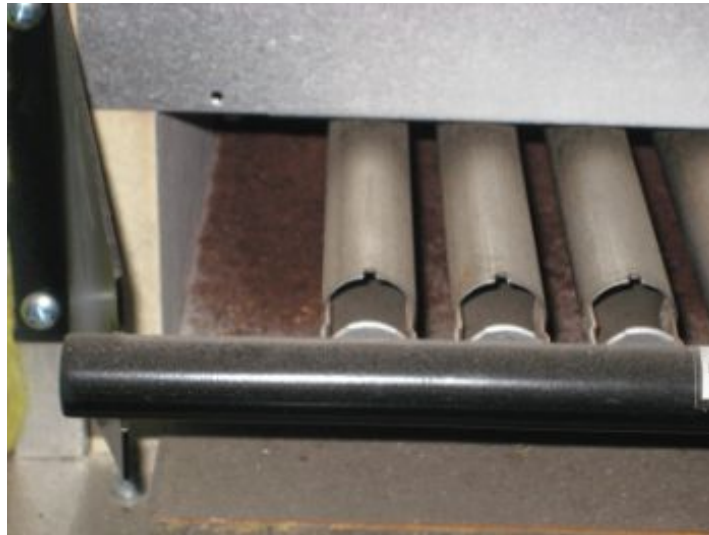
Rust flakes were present in the combustion chamber

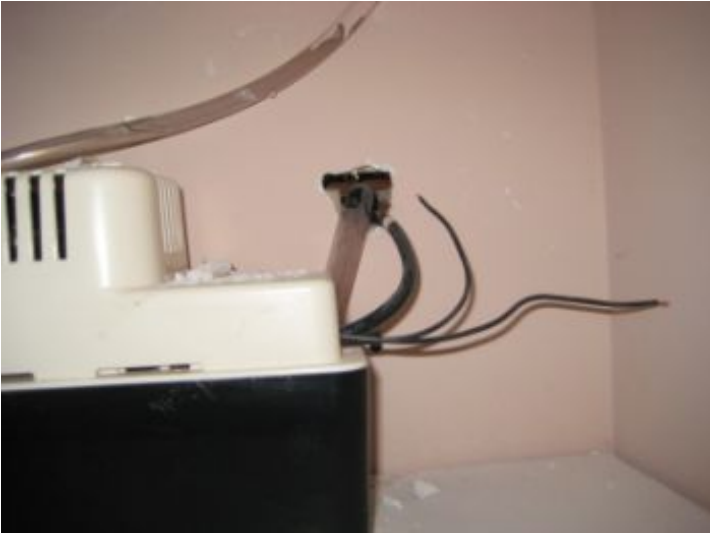
2nd floor condensate pump in plugged into a concealed outlet

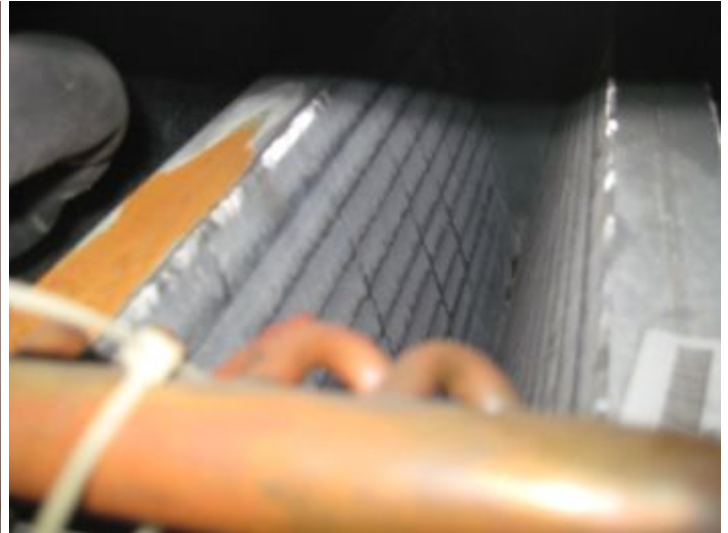
3rd floor evaporator coil is corroded

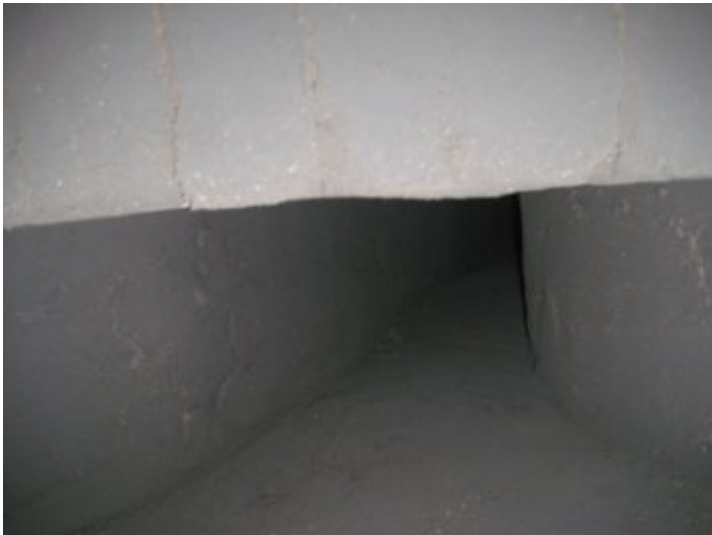
Flues were substantially deteriorated

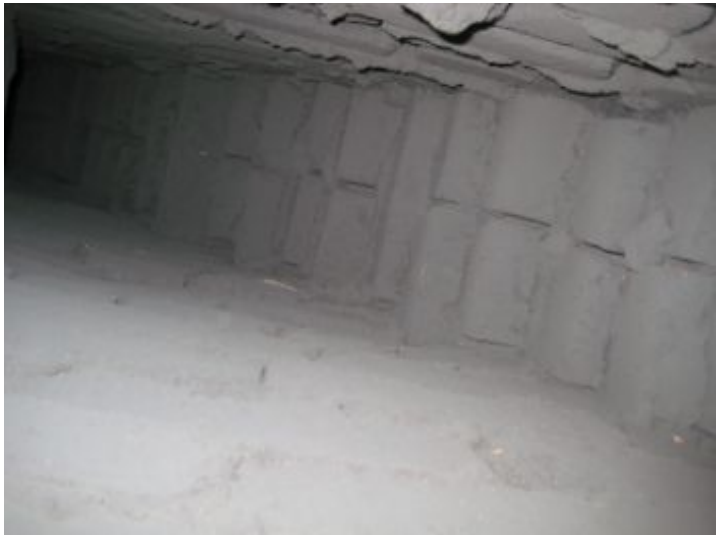
Flues were substantially deteriorated

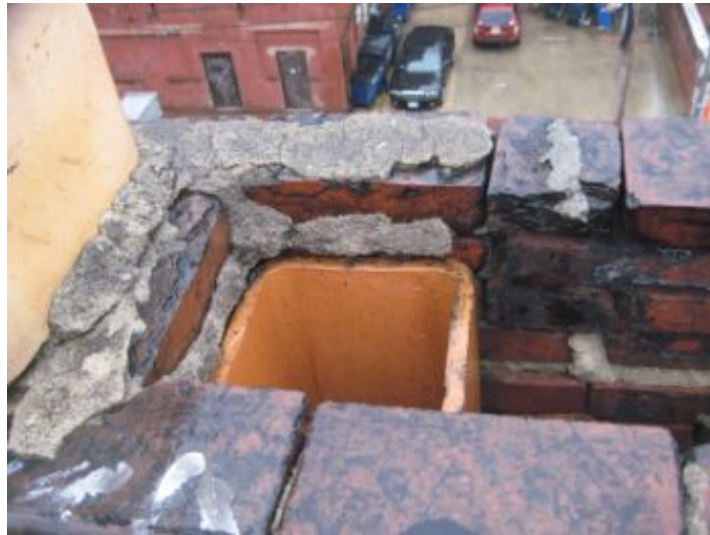
Flues were substantially deteriorated

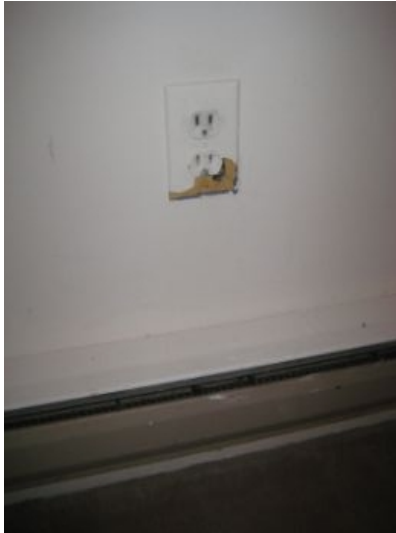
Electrical outlets were located over electric baseboard heaters - fire hazard

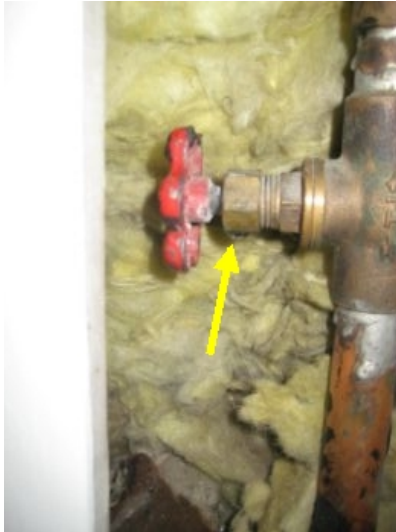
Shut off valve at basement was leaking at the time of the inspection

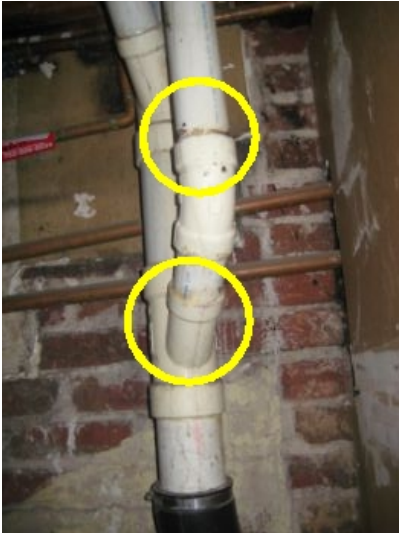
Main drain/waste line in basement mechanical room was leaking at the time of the inspection

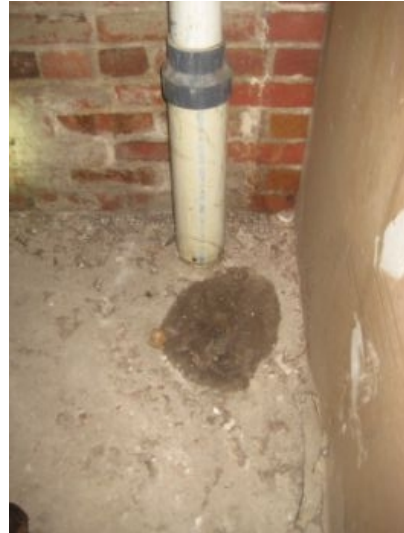
Main drain/waste line in basement mechanical room was leaking at the time of the inspection

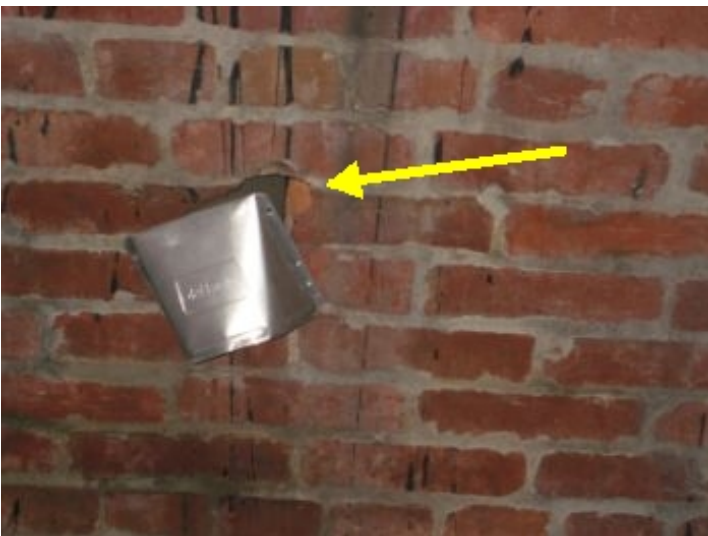
Exhaust fan duct caps were missing or damaged at the exterior

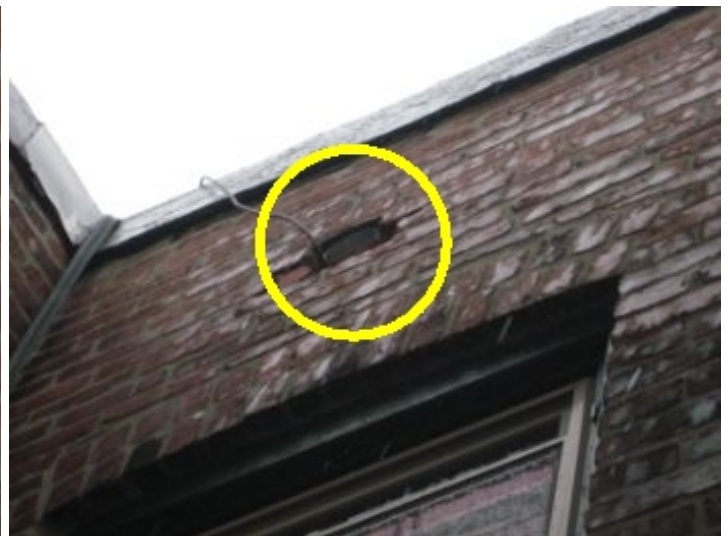
Exhaust fan duct caps were missing or damaged at the exterior
